## Chapter Four

### The Macondo Well and the Blowout

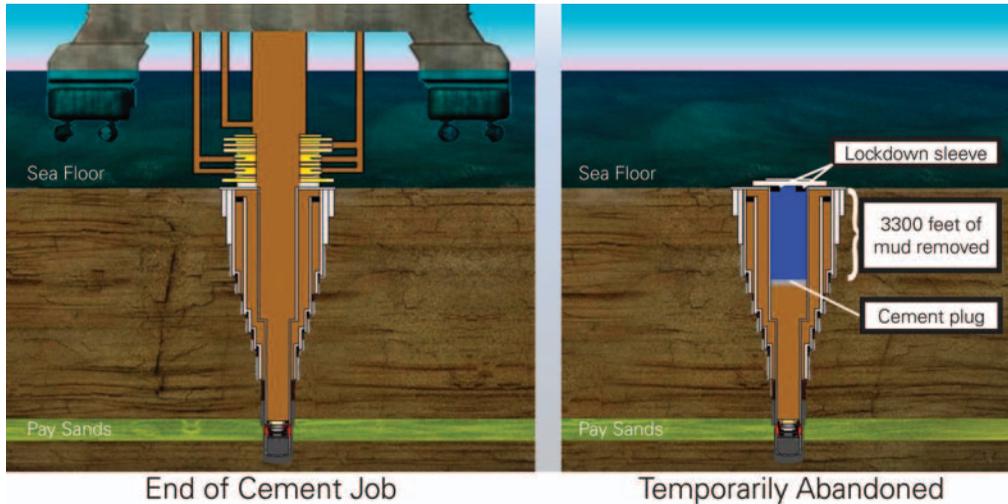
**FIGURE 4.5: Temporary Abandonment**

The status of the well before and after temporary abandonment.

Four features of the temporarily abandoned well are worth noting. First is the single 300-foot-long cement plug inside the wellbore. MMS regulations required BP to install a cement plug as a backup for the cement job at the bottom of the well. Second is the location of the cement plug: BP planned to put it 3,300 feet below the ocean floor, or “mud line” (which was deeper than MMS regulations allowed without dispensation, and deeper than usual).<sup>58</sup> Third is the presence of seawater in the well below the sea floor: BP planned to replace 3,000 feet of mud in the wellbore above the cement plug with much

*It was not necessary to set the cement plug 3,300 feet below the mudline.* The BP Macondo team chose to do so in order to set the lockdown sleeve last in the temporary abandonment sequence to minimize the chances of damage to the sleeve. Setting the lockdown sleeve would require 100,000 pounds of force. The BP Macondo team sought to generate that force by hanging 3,000 feet of drill pipe below the sleeve—hence the desire to set the cement plug 3,000 feet below the mud line. BP's desire to set the lockdown sleeve last did not justify the risks its decision created. BP could have used other proven means to protect the lockdown sleeve if set earlier in the process. It also did not need 3,000 feet of space to generate 100,000 pounds of force.<sup>147</sup> Merrick Kelley, the individual at BP in charge of lockdown sleeves in the Gulf of Mexico, told Commission staff that he had recommended setting the plug roughly 1,300 feet below the mud line (using heavier drill pipe), rather than 3,300 feet down. That would have significantly increased the margin of safety for the well.<sup>148</sup>

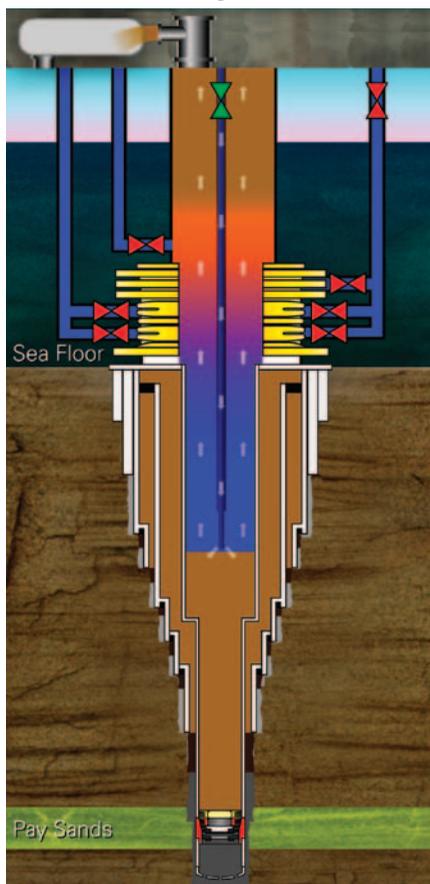
**FIGURE 4.6: Displacing Mud With Spacer and Seawater Before the Negative Pressure Test**

liquid mixture that serves to separate the heavy drilling mud from the seawater—followed by seawater down the drill pipe to push (displace) 3,300 feet of mud from below the mud line to above the BOP. (Figure 4.6)

Seawater (blue) displaces mud (brown) from wellbore and riser, with spacer fluid separating the two.
